**AVIATION INVESTIGATION REPORT  
A04H0004**

**REDUCED POWER AT TAKE-OFF AND COLLISION WITH  
TERRAIN**

**MK AIRLINES LIMITED  
BOEING 747-244SF 9G-MKJ  
HALIFAX INTERNATIONAL AIRPORT, NOVA SCOTIA  
14 OCTOBER 2004**

Report Number A04H0004

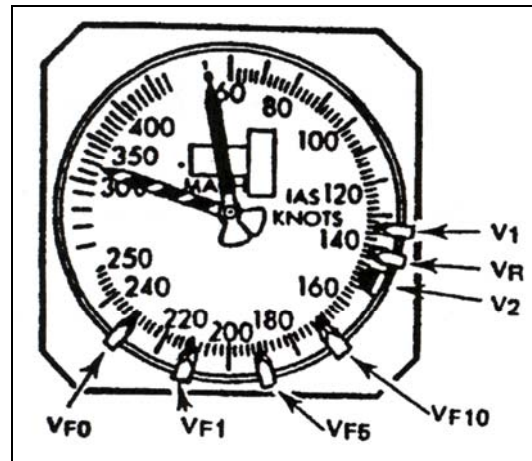
Figure 5. Example of bug settings for take-off

To remind the pilots of their target EPR settings, a moveable pointer bug is pre-set on each of the four EPR indicators on the pilots' centre instrument panel (see Figure 5). The indicators have two modes, manual and automatic. In manual mode, the knob is pulled out and an M flag replaces the left digit in the upper window. The bug and upper digital readout respond to the rotation of the knob. In automatic mode, the knob is in, the M flag is out of view, and the bug and upper digital readout responds to the TAT/EPRL (true air temperature/engine pressure ratio limit)<sup>22</sup> mode selector. Climb EPR and go-around EPR are taken from the MK Airlines Limited QRH and transcribed onto the take-off data card.

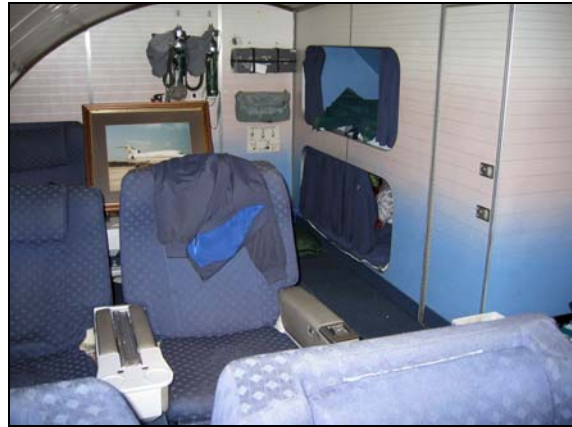
**Photo 8.** Upper deck crew rest area

The on-board rest facilities on the accident aircraft included a captain's cabin, two bunks, and first-class seats (see Photo 8). The operating captain and the first officer would have had the opportunity to sleep on board the aircraft while transiting from Luxembourg to Bradley. However, other MK Airlines Limited crews indicated that they rarely were able to sleep on the first leg of the MKA1601/MKA1602 route because of the time of day. They also stated that they began to feel the effects of fatigue during the stopover in Halifax and might obtain a nap in Halifax, if the turnaround time permitted. Feeling fatigued at this stage of the flight would be consistent with the expected lowest point of a crew member's circadian rhythm. In the case of the accident flight, which was delayed leaving Luxembourg, the circadian low point would have fallen somewhere between Bradley and Halifax. Other crews also indicated that they normally were able to get several hours of sleep while transiting between Halifax and Zaragoza.
